Classy Chassis

BOREDOM STRIKES – WIFE INSISTS I BUY ANOTHER CAR

A Good Year with Good Progress: 1901 Orient

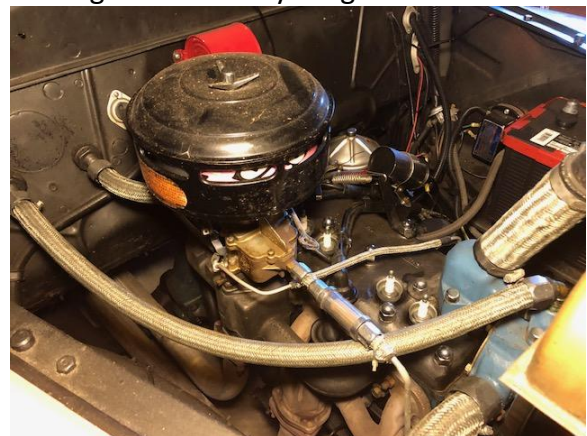
Engine upon arrival – STUCK

Marvel Mystery Oil, and rocking the car to no avail, we decided that we had to pull the head. Once the head was off, we discovered that there were marks in the pistons from a star washer, and one piston was cracked down to the ring. We pulled the pan down and disconnected the rod bearings. The oil was so black and thick that I had to use a putty knife to remove the oil. The crank turned freely and the head itself looked good. Then the tapping of the

pistons began. More soaking including the secret ingredient Home Made Vinegar and tapping!! Eventually we were able to get a 5 of the 6 pistons out, but the last piston took a 10 pound sledge hammer to remove. Fortunately all the piston walls were still in original spec, so a new set of pistons, new rings and push rod bearings and one new

valve, and we were able to put the engine back together without taking it out of the car. We pushed it out to the door, and turned over the engine. After 3 or 4 tries, it started. Billowing smoke from all the fluids we put down the exhaust pipes, it took about 5 or 10 minutes, and it cleared up, purring like a kitten.

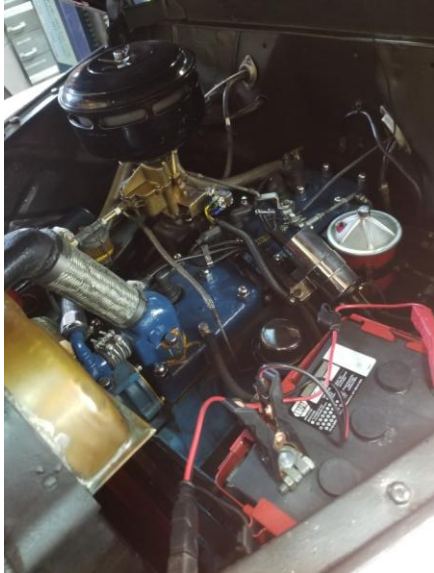
Finished Engine

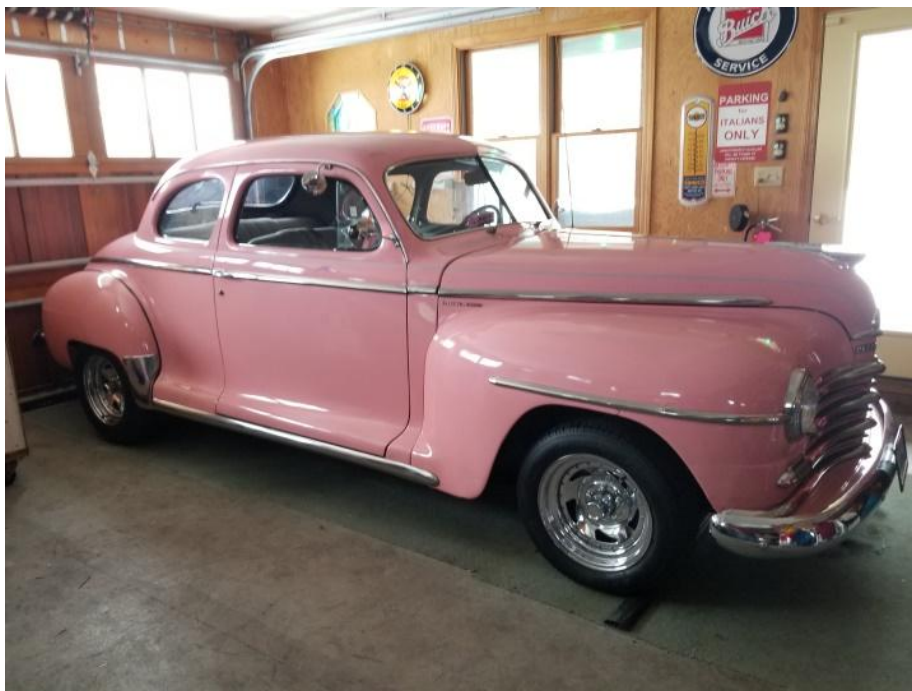
Ready for Cruising

We since have gotten all the minor issues corrected, including wiring the overdrive, universal joint boots, new seat tracks, and RF brake backing plate. The car is ready for summer cruising. **Dave Calabrese**

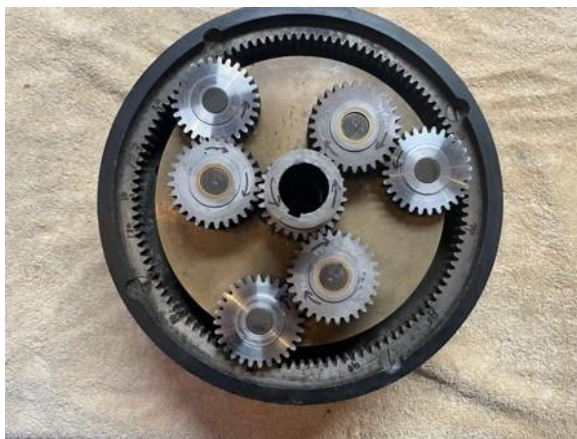
Planetary Gears

The new gears are the shiny ones. There is a set of three gears that are in contact with the large, inner-facing drum gear on the forward direction.

This is a pretty complex planetary transmission. The gear in the center, with the keyway in it, is the sun gear. Outside of that are the three planet gears. Outside of the planet gears are the three moon gears. They are also inside of the drum gear as mentioned before.

The best way for me to bring you up to date is to start with setbacks and progress we had near late last year. The first problem was when I found that I was missing two gears from the transmission. It is a planetary transmission so there are many gears. The two ones missing were two of three originals that did the same job.

I needed to have new gears made so I had three done so all of them would be identical. I have a friend who owns a gear company in Yalesville, CT. ([JoVal Machine Shop](#)). He is an old car guy who's newest car is a 1909. I knew that he was the right man for the job. His company expected the machining of the gears take three weeks. Covid nearly closed them but they were able to work some hours on four days a week. They did a high quality job but it took three months.

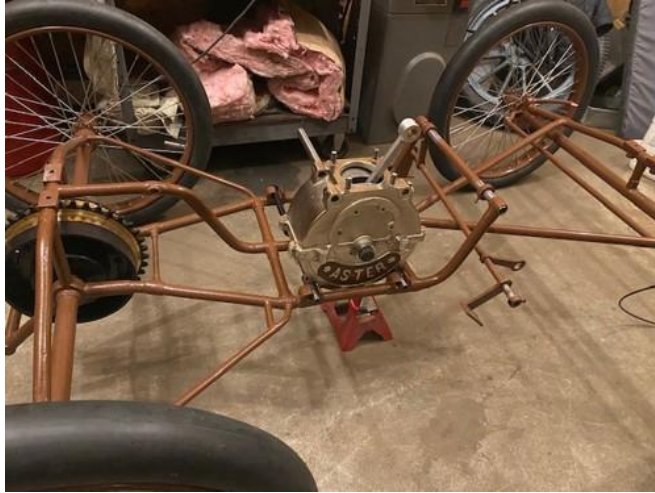
Below is the engine in the car. You can see the flywheels with the connecting rod between the

two of them. The small, black gear on the near end of the crankcase is the pinion gear on the short pinion shaft. You can also see the long transmission shaft on the back side of the engine. The engine has now been totally assembled (**below, left**) and we are preparing it for the upcoming test run. I do not have enough room here to tell of the work we have accomplished on all the little parts. However, I do want to send you one photo from last fall that

The first step was to balance the two flywheels. One of the major reasons for the balance changes was the fact that we made a new connecting rod of aluminum and installed a new Harley-Davidson aluminum piston. The balancing went well although it took a lot of holes to get it done.

When the shop began to ensure that the rotation of the three shafts attached to the flywheels was straight they found that the pinion shaft and crank pin were fine but the long shaft that runs from the flywheel through the transmission was bent .005 inches. Even though we had replaced this shaft the material we used was not within tolerance.

I purchased a new shaft made of chrome-moly steel in an oversize diameter. The motorcycle shop machined it and I then brought it to a precision grinder that I have used for years. They did a wonderful job and the shop got the whole thing put together well within tolerances.

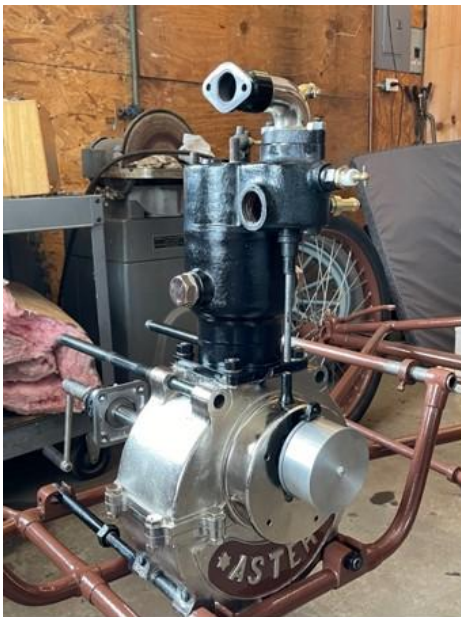
Assembled Engine

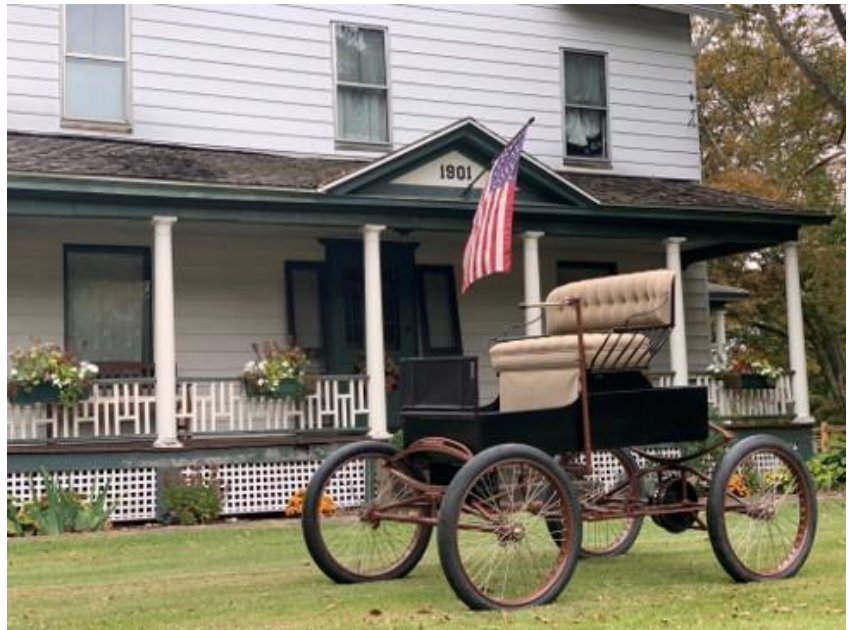
shows our progress to that point. This is the completed body of the 1901 Orient. The new wheels are complete as is the original wooden body. The original seat was reupholstered in New York. At the time this photo was taken, the transmission and engine were out being worked on but it still makes a nice photo.

Completed Body and New Wheels
